**DESABLA-CENTERVILLE HYDROELECTRIC PROJECT  
FERC PROJECT No. 803**

**DRAFT  
HISTORIC PROPERTIES MANAGEMENT PLAN**

**PACIFIC GAS AND ELECTRIC COMPANY**

**February 2008**

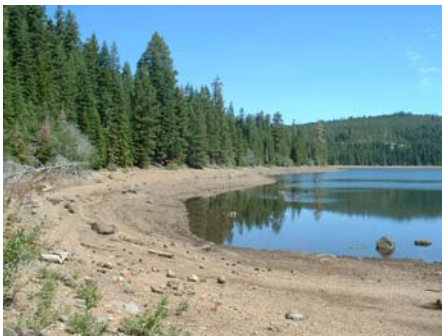
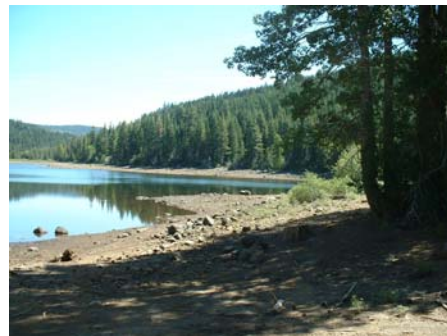
**Figure 1.1.1-1.** Round Valley Reservoir

**Figure 1.1.1-2.** Round Valley Reservoir

Round Valley Reservoir (also known as Snag Lake; Figures 1.1.1-1 and 1.1.1-2) is near the head of the WBFR, at the upper end of the Project Area. Round Valley Reservoir has a maximum depth of about 25 feet, holds approximately 1,200 acre-feet with a spillway elevation of 5,651.1 feet, and is more than 12 stream miles above Hendricks Diversion Dam. The dam has a simple overflow spillway and has no gates or flashboards. The reservoir is drained each summer, and then filled with fall and winter rains. The dam has a simple overflow spillway and has no gates or flashboards. The spillway is on the south side of the dam. Curved stone retaining walls lead into the spillway, which is approximately 16 feet wide. Parts of the original fieldstone walls have been replaced with concrete.

Built in 1877, the Round Valley Dam is located at the headwaters of the West Branch Feather River. It is an earthen dam approximately 29 feet high, with a crest 850 feet long and 8 feet wide. Both the upstream and downstream slopes are 2.5 horizontal to 1 vertical. Although built for mining or other uses prior to PG&E's inception, it was one of the original features acquired by PG&E for the DeSabra-Centerville Project. In 1932 seepage from the dam was noticed. In 1940 the company constructed weirs on the downstream face of the dam to monitor this leakage. In 1965 the dam was repaired and renovated, including removing trees that had grown on the dam, renovating the embankment by replacing it with "proper compacted fill, thus removing all roots and stumps" from the top 15 feet of the dam. In addition the gate stem pedestal and the downstream toe drain were replaced (PG&E 1965). In 1990, the California Department of Water Resources, Division of Safety of Dams, stated that the dam needed rehabilitation; this entailed a "combination of a filter blanket with subsurface drains to control seepage and prevent long-term erosion" (Palmer 1994).

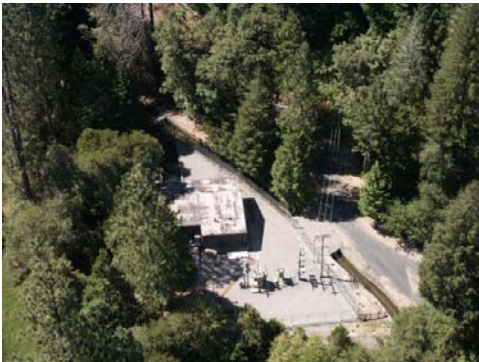
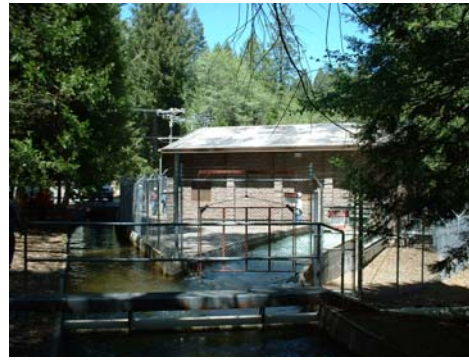
**Figure 1.1.1-7.** Toadtown Powerhouse Aerial View

**Figure 1.1.1-8.** Toadtown Powerhouse Ground View

Toadtown Powerhouse (Figures 1.1.1-7 and 1.1.1-8) was built in 1986 on Little Butte Creek. The Hendricks Canal carries water to the powerhouse and then into the Toadtown Canal, eventually reaching the DeSabra Forebay via the Butte Creek Canal. Toadtown Powerhouse is fed by water from Hendricks Canal through a welded steel penstock. The powerhouse is located 8.66 miles downstream of Hendricks Diversion Dam. There is no storage reservoir associated with the powerhouse. Toadtown Powerhouse is a reinforced concrete building approximately 28 feet by 44 feet, housing one turbine-generator unit. The main floor is at elevation 2,825.0 feet. The unit is a Francis turbine and has a normal maximum gross head of 185 feet, a rated flow of 134 cfs, with a normal operating capacity of 1.5 MW. A 1,500 foot-long 12 kV tap line follows the Project access road and connects the project to the Licensee's distribution system.

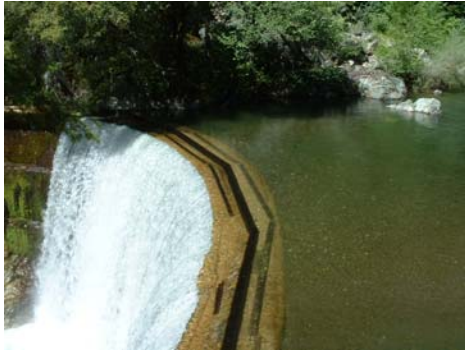
**Figure 1.1.2-1.** Butte Creek Diversion Dam

Water is diverted from Butte Creek at the Butte Creek Diversion Dam (Figure 1.1.2-1), a concrete arch dam approximately 50 feet high, into the Butte Canal. The dam has an overflow spillway at an elevation of 2,884 feet. The diversion dam structure was built in 1916 to replace a log crib dam at the same location. It is 110 feet long, 45 feet high, 4 feet thick at the top and 8 feet thick at the bottom. The poured concrete intake is located on the right side of the dam. A sliding gate controls the 5 by 6 foot arched opening, which connects to a short tunnel under a knoll. The water travels through the tunnel and into the Butte Creek Canal. Residual water flows back into Butte Creek. A steep concrete stairway, no longer used, begins at the east side of the dam and ends close to the top of the knoll. The stairs were originally connected to a walkway that led to the intake and to the top of the knoll

In 1916, PG&E followed Wise's advice and replaced the log crib head dam for Butte Creek Canal with a concrete dam. The new dam was a cyclopean concrete arch 110 feet long and 45 feet high. The dam was 4 feet thick at the top and 8 feet thick at the bottom (Department of Water Resources 1930). It diverted the water from the creek into a tunnel that led to the canal. On the opposite side of the tunnel the residual water was returned to Butte Creek.

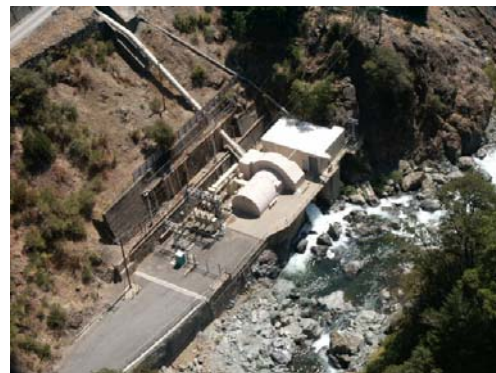
**Figure 1.1.2-6.** DeSabla Powerhouse

The original DeSabra Powerhouse (Figure 1.1.2-6) was built in 1903 and demolished in 1961. In conjunction with the new powerhouse, new penstocks and intake were also installed. DeSabra Powerhouse is a reinforced-concrete structure with a control building approximately 26.5 feet by

41 feet, with one turbine-generator unit. The main floor is at elevation 1,222.5 feet. The turbine unit is a 25,000 hp Pelton horizontal turbine with a normal maximum gross head of 1,530 feet and a nameplate flow of 191 cfs. A 0.25-mile-long transmission tap line connects the powerhouse to the 60 kV Oro Fino Tap Line.

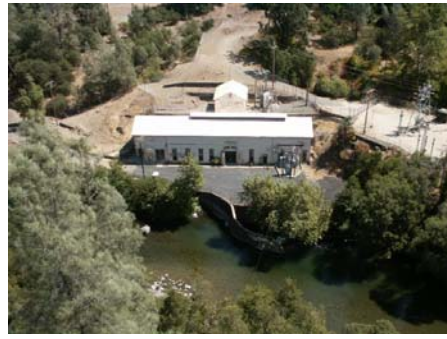
**Figure 1.1.3-2.** Centerville Powerhouse

Built in 1899 in the California Industrial style with Greek Revival elements, the powerhouse was refurbished by PG&E in 1907 and 1908 by raising its concrete walls to accommodate a new turbine and crane (Van Bueren 1985: 29). The structure has a rectangular footprint and the front façade faces west. The foundation and floor is poured concrete set in two-foot square blocks. The tapered walls are also concrete; a metal truss supports the gabled roof capped with a monitor-styled ventilator. Metal columns support the traveling crane and delineate six interior bays, each approximately 18 feet long. Pendant lights are attached to the columns.

The powerhouse was automated in 1959 and routine maintenance is required to keep the equipment in working order. However, there have been no major changes to the interior or exterior of the building.

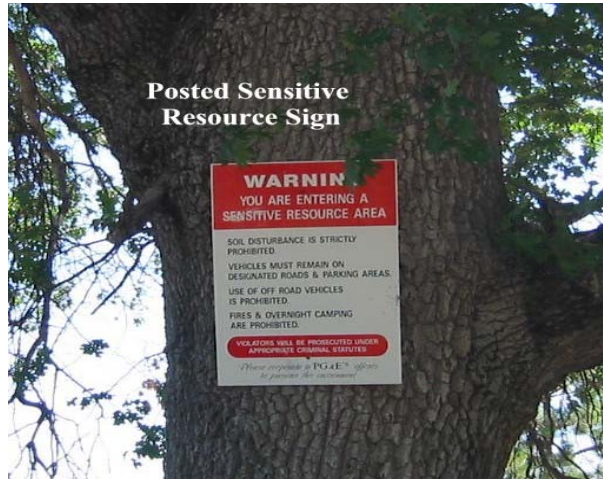
**Figure 4.3.1-1. Warning Sign/Sensitive Resource Area:**  
Signs to this effect will be posted throughout the Project Area in locations easily viewed from roads and developed recreation areas.

Regulatory warning signs will be clearly posted in protected, sensitive areas to warn the public that violators will be vigorously prosecuted. Signs will be highly visible and placed at access points for potentially vulnerable historic properties. Signs effectively warn the public that they are in a protected area and serve as an enforceable notice of that warning. Careful placement of signs is crucial so as not to increase public knowledge of site locations thereby making the properties more vulnerable to vandalism. Appropriate wording for the signs and their placement will be developed in consultation with PG&E cultural resources personnel, Corporate Security and legal advisors, local, state and federal law enforcement agencies, the appropriate Native American communities and resource management specialists.

Throughout the Project Area, historic properties may be subject to various forms of impacts, including vandalism from looters and damage caused by off-highway-vehicles. Adequate signage notifying users about regulations and restrictions in sensitive areas are essential for the successful prosecution of violators. Signs to the following effect (Figures 4.3.1-1 through 4.3.1-3) will be placed at designated locations throughout the Project Area. USFS/BLM permission and approval of final sign design must be obtained prior to placing signs on NFSL or BLM lands.

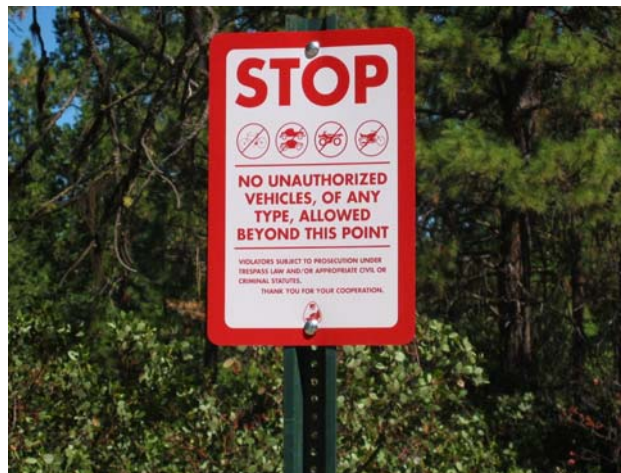
**Figure 4.3.1-2. Warning Sign/No Unauthorized Vehicles:**  
Signs to this effect will be posted in select locations along public roads where OHVs have traveled off-road and on Project roads that are used only for administrative purposes by PG&E, resource agencies, and law enforcement personnel.
